11 Jul 2023 • BRA - Bramble Academy

# **Inspection report**

The Bramble Academy Oxclose Lane Mansfield Woodhouse NG19 8DF	Date Of Inspection:05/07/23
Responsible Person: Panayiota Theodosiou	Name Of Inspector(s): Billy Shaw
SENDCo: Maya Dalby	Relevant Contacts: John Wesson (Regional Premises Manager), Danial Wheatley (Site Manager)

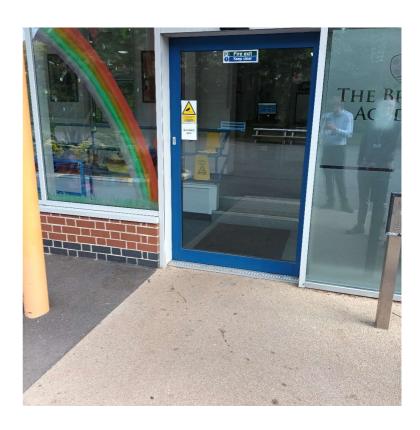
Registration drawing

Entrances/Reception

**ACTION REQUIRED - 1 MONTH**

Full length glass doors require sufficient manifestation markings installing in line with Approved Doc K

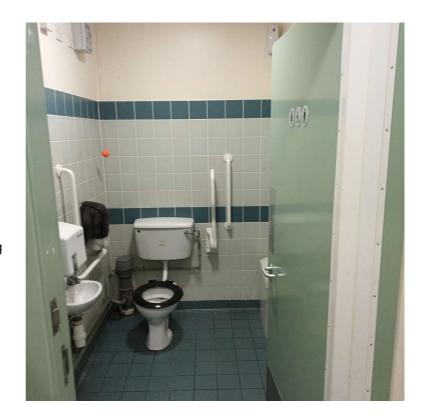
Registration drawing

Accessible Toilets/Hygiene Rooms

Accessible toilet arrangements in the dining area may require possible improvements, this would include extensive works to bring the room to the recommended size (2200mmx1500mm) in addition to sufficient grab rails, contrast, etc.

There are however no pupils that require use of an accessible toilet, however consideration must be taken to improving these facilities where possible.

Adaptations or sufficient temporary arrangements will be required in the event of a pupil attending the academy with additional requirements.

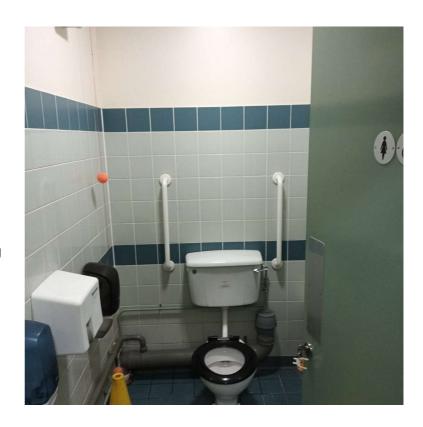
Registration drawing

#### Accessible Toilets/Hygiene Rooms

Accessible toilet arrangements in the dining area may require possible improvements, this would include extensive works to bring the room to the recommended size (2200mmx1500mm) in addition to sufficient grab rails, contrast, etc.

There are however no pupils that require use of an accessible toilet, however consideration must be taken to improving these facilities where possible.

Adaptations or sufficient temporary arrangements will be required in the event of a pupil attending the academy with additional requirements.

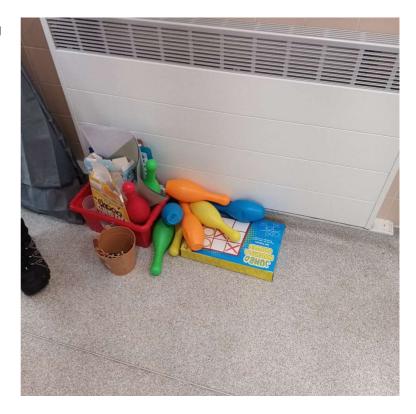
Registration drawing

### **ACTION REQUIRED - IMMEDIATE**

Accessible toilet is obstructed due to being used as a storage area.

Clear obstructions and ensure that the accessible toilet is fit for purpose.

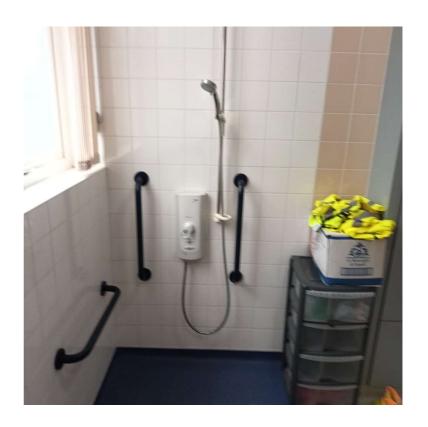
Registration drawing
Inspector

### **ACTION REQUIRED - 6 MONTHS**

Emergency communication pull is not accessible.

No seat installed within shower.

Emergency communication pull should be within reach of the toilet, with a red triangle positioned at 100mm, and between 800mm - 1000mm from the floor.

Install seat at 480mm in line with approved doc M

There are currently two rooms containing showers within the academy, it may be determined which of these is the designated hygiene room with works prioritized between the rooms as necessary.

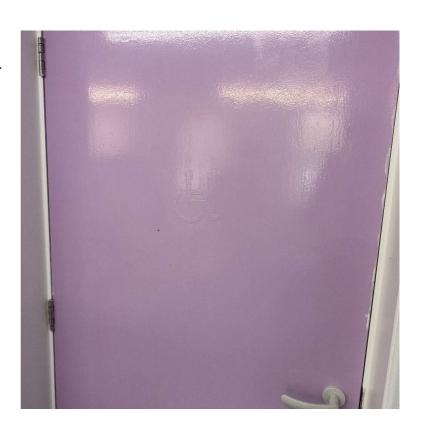
Registration drawing

**ACTION REQUIRED - 1 MONTH**

Accessible toilet signage is unsuitable and requires replacing with adequate signage.

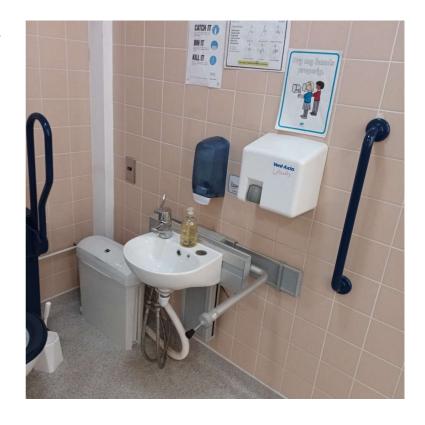
Registration drawing

**ACTION REQUIRED - 6 MONTHS**

Grab handles and rails in wrong position.

Missing grab rail

Relocate to correct positions following guidance in Approved Doc M.

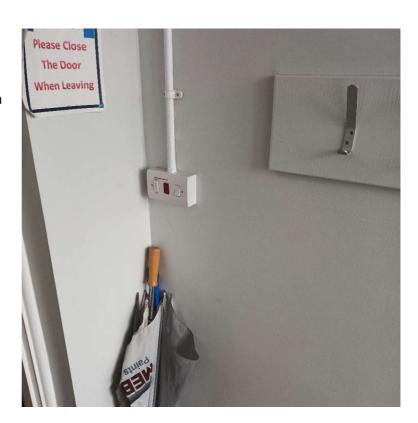
Registration drawing

### **ACTION REQUIRED - 6 MONTHS**

Light switches in accessible toilets should be easily operable with a closed fist.

Although there are no persons currently in attendance that require use of an accessible toilet consider changing light switch to a unit more suitable.

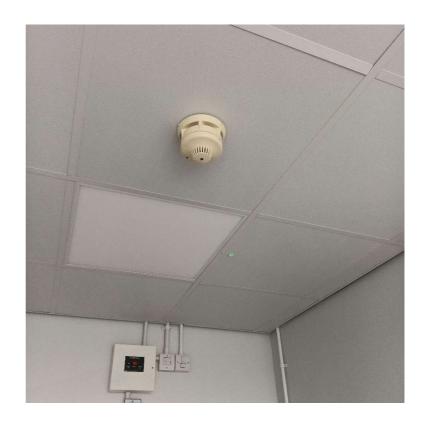
Registration drawing

### **ACTION REQUIRED - 6 MONTHS**

Accessible toilets within the academy require visual beacons installing.

All accessible toilets should be checked with replacement beacons installed as necessary.

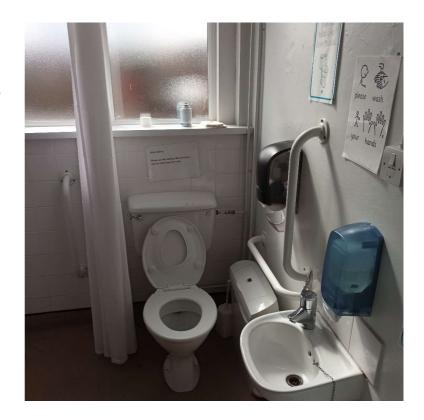
Registration drawing

**ACTION REQUIRED - 1 MONTH**

Emergency communication pull is not accessible.

Emergency communication pull should be within reach of the toilet, with a red triangle positioned at 100mm, and between 800mm - 1000mm from the floor.

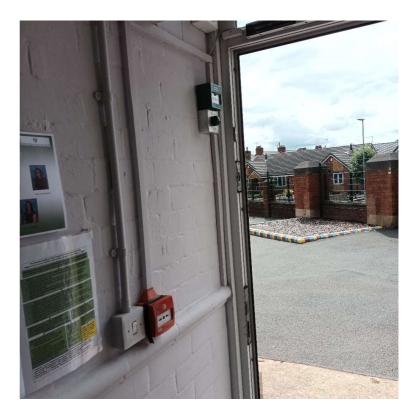
Registration drawing

### **ACTION REQUIRED - 6 MONTHS**

There are several emergency door release controls ore positioned too high.

Emergency door release controls should be positioned between 800mm-1200mm from ground level to allow ease of access.

All control units within the academy should be checked and repositioned where necessary.

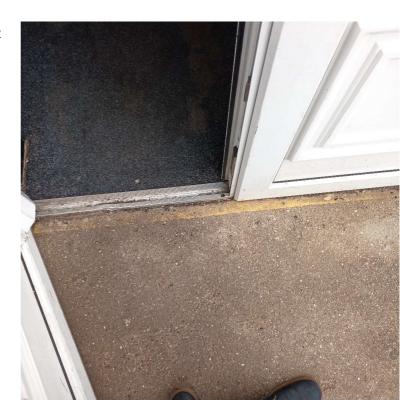
Registration drawing

**ACTION REQUIRED - 1 MONTH**

Edgings of steps/ stairs are damaged/ not marked.

Mark edges of steps/stairs with a slip resistant and contrasting nosing extending along the full width of the step to a depth of 50mm on tread and riser.

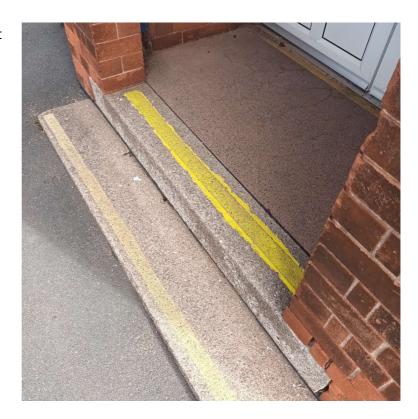
Registration drawing

Edgings of steps/ stairs are damaged/ not marked.

Mark edges of steps/stairs with a slip resistant and contrasting nosing extending along the full width of the step to a depth of 50mm on tread and riser.

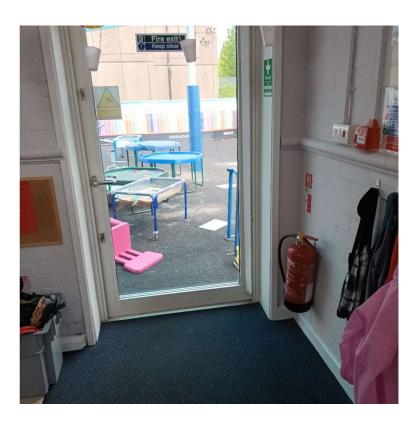
Registration drawing

**ACTION REQUIRED - 1 MONTH**

Full length glass doors require sufficient manifestation markings installing in line with Approved Doc K

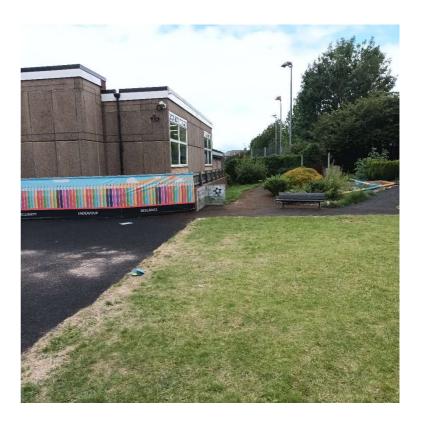
Registration drawing

There are a multiple trip hazards present within this area of the playground.

The area is due for refurbishment throughout the summer period.
